ROADS & BRIDGES

COMPLETING 16 LANE-MILES OF FULL-DEPTH RECLAMATION FOR FIRE-DAMAGED ROADWAY IN CALAVERAS COUNTY, CALIFORNIA

This feature published as "After the Fire" in February 2022 issue

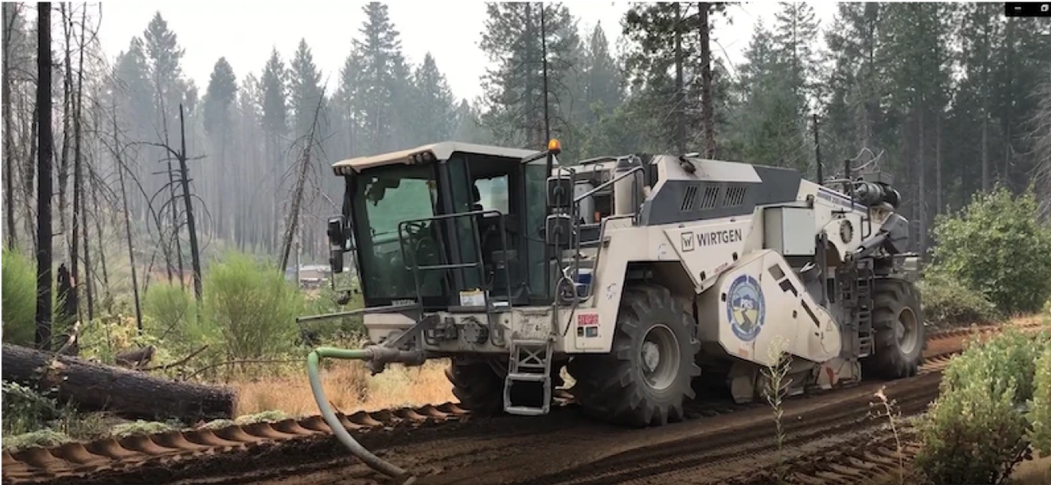
Pavement Recycling Systems pulverizing Jesus Maria road with a Wirtgen WR 250i cold recycler. The pulverization process includes the mixing of cement and water with existing asphalt and base to a depth of 9 in.

The entire FDR area was measured to be approximately 78,360 sq yd. The work consisted of spreading cement on existing asphalt surface at a rate determined by the mix design, mixing cement and water with existing asphalt and base to a depth of 9 in., followed by grading and final compaction. At the end of each week, a fog seal coat was applied to the FDR-C surface to prepare for the final cape seal process. The FDR-C process took 15 days to complete, meeting the predetermined schedule.

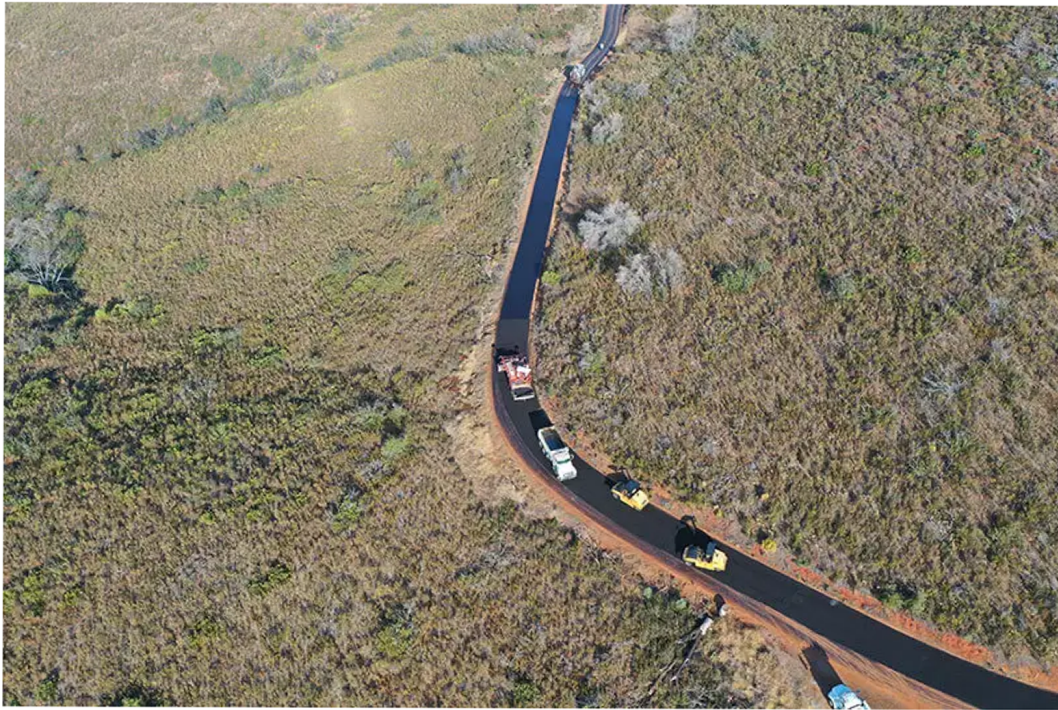
VSS International crews performing chip seal treatment to Jesus Maria Road. An oil spreader sprays polymer modified CRS emulsion to the roadway followed by an application of 3/8-in. chips with pneumatic tire rollers behind the chip box to lock in the chip seal treatment.

Following this process, VSS International's crews placed a conventional chip seal over the FDR surface. The chips used were 3/8-in. washed chips from George Reed's Table Mountain Quarry and the emulsion was a polymer modified CRS. The 78,360 sq yd FDR-C was covered with chip seal in only two days using approximately 950 tons of 3/8-in. chips and 95 tons of polymer modified CRS emulsion supplied by VSS Emultech.
